XE166N Derivatives

16-Bit Single-Chip
Real Time Signal Controller
XE166 Family / Value Line

Errata Sheet

V1.3 2009-06

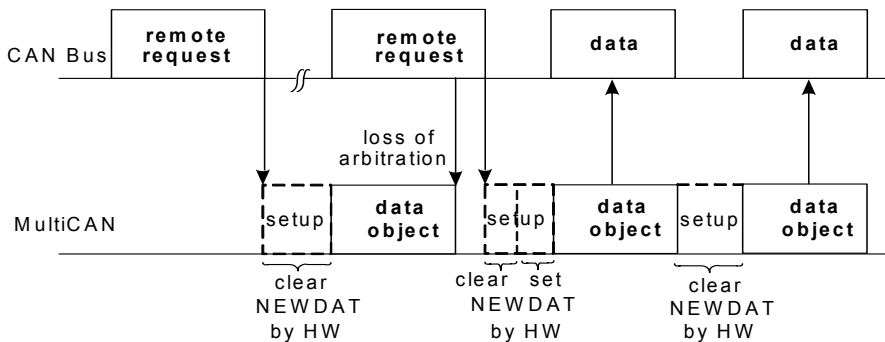
Figure 1 Loss of Arbitration

When the appropriate message object (data frame) triggered by the first remote frame wins the arbitration, it will be sent out and `NEWDAT` is not reset. This leads to an additional data frame, that will be sent by this message object (clearing `NEWDAT`).

There will, however, not be more data frames than there are corresponding remote requests.
