Stellaris[®] LM3S1N16 RevB1 Errata

This document contains known errata at the time of publication for the Stellaris[®] LM3S1N16 microcontroller. The table below summarizes the errata and lists the affected revisions. See the data sheet for more details.

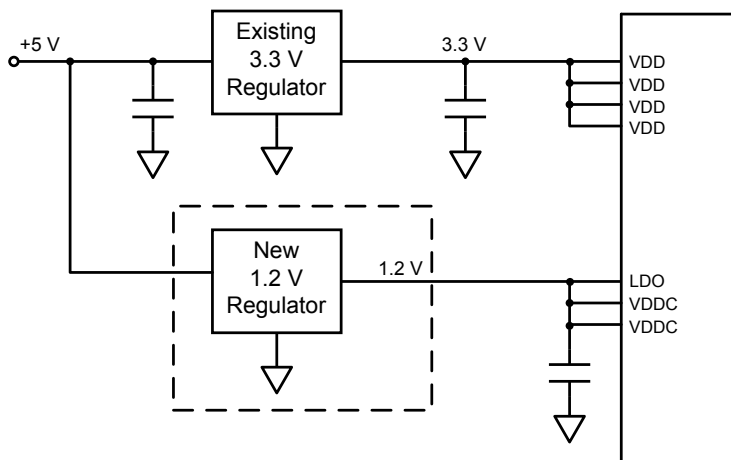
Figure 2. Configuration of External Regulator

Incorrect power sequencing during power up can disrupt operation and potentially cause device failure.

V_{DDC} must be applied approximately 50 μ s before V_{DD} . Normally V_{DDC} is controlled by the part's internal LDO voltage regulator. The workaround requires the addition of an external regulator (see Figure 2) to ensure that V_{DDC} sequencing requirements are met (see Figure 3). Recommended regulators include FAN1112SX (SOT223) and FAN2558S12X (SOT23-5).

This fix mitigates the on-chip power issue, but does not solve it completely. During development, the Flash memory should also be reprogrammed (using LMflash or another programming tool) at least once a week.
