## Stellaris<sup>®</sup> LM3S1Z16 RevB1 Errata

This document contains known errata at the time of publication for the Stellaris<sup>®</sup> LM3S1Z16 microcontroller. The table below summarizes the errata and lists the affected revisions. See the data sheet for more details.

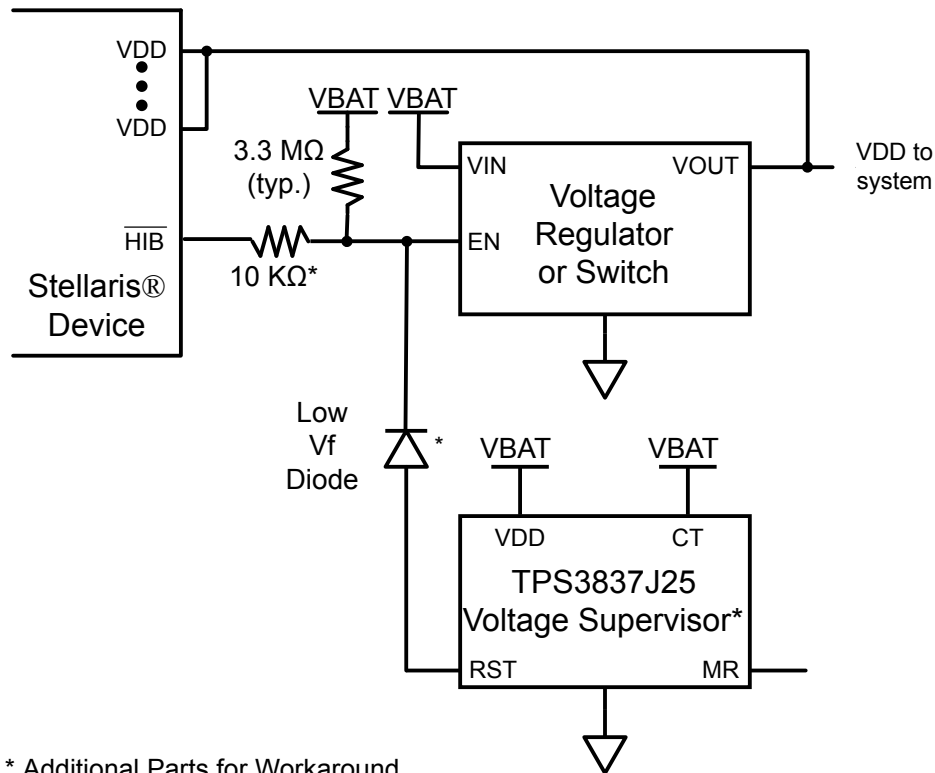
Figure 1. Workaround Circuit to Ensure Initial Power Up

If  $V_{DD}$  is not powered when voltage is first applied to  $V_{BAT}$ , the state of the Hibernation module is indeterminate and the  $\overline{HIB}$  signal may be asserted. In this indeterminate state, a lock condition can occur in which the Hibernation module waits for a power-on-reset, but that reset cannot occur until the module deasserts  $\overline{HIB}$ . This issue is related to the errata "Hibernation module may have higher current draw than specified in data sheet under certain conditions" on page 5.

The workaround implementation depends on the system-level power supply configuration. For systems that use a battery as the primary power source, an external voltage supervisor (TPS383J25DBV or similar) circuit can be added to force the  $V_{DD}$  power supply to start when the battery voltage is first applied (see Figure 1). The voltage supervisor requires only 220 nA and generates a 200-ms positive pulse to turn on the  $V_{DD}$  regulator and activate the microcontroller's internal POR circuit.

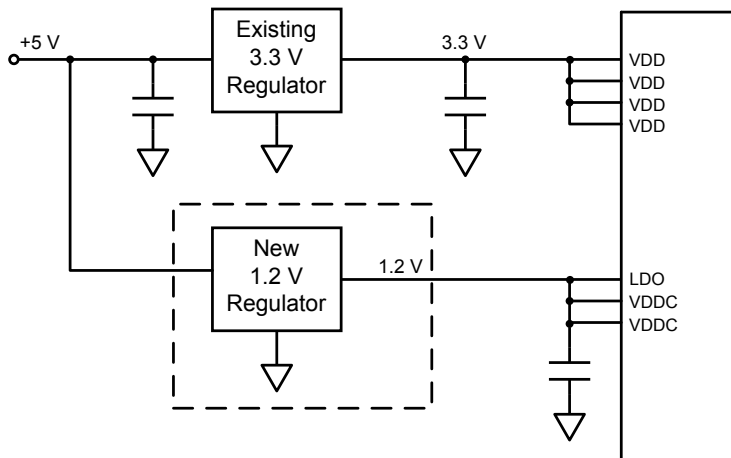
**Figure 2. Configuration of External Regulator**

Incorrect power sequencing during power up can disrupt operation and potentially cause device failure.

$V_{DDC}$  must be applied approximately 50  $\mu$ s before  $V_{DD}$ . Normally  $V_{DDC}$  is controlled by the part's internal LDO voltage regulator. The workaround requires the addition of an external regulator (see Figure 2) to ensure that  $V_{DDC}$  sequencing requirements are met (see Figure 3). Recommended regulators include FAN1112SX (SOT223) and FAN2558S12X (SOT23-5).
