Stellaris[®] LM3S3J26 RevB1 Errata

This document contains known errata at the time of publication for the Stellaris[®] LM3S3J26 microcontroller. The table below summarizes the errata and lists the affected revisions. See the data sheet for more details.

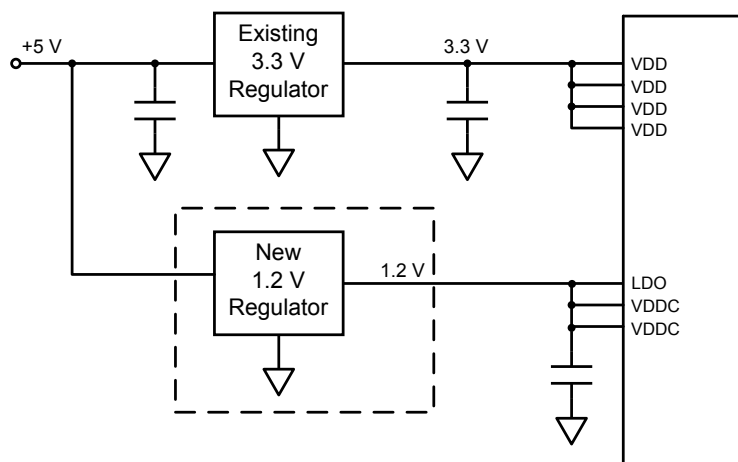
Figure 2. Configuration of External Regulator

Incorrect power sequencing during power up can disrupt operation and potentially cause device failure.

V_{DDC} must be applied approximately 50 μ s before V_{DD} . Normally V_{DDC} is controlled by the part's internal LDO voltage regulator. The workaround requires the addition of an external regulator (see Figure 2) to ensure that V_{DDC} sequencing requirements are met (see Figure 3). Recommended regulators include FAN1112SX (SOT223) and FAN2558S12X (SOT23-5).

This fix mitigates the on-chip power issue, but does not solve it completely. During development, the Flash memory should also be reprogrammed (using LMflash or another programming tool) at least once a week.
