Stellaris[®] LM3S5656 RevB1 Errata

This document contains known errata at the time of publication for the Stellaris[®] LM3S5656 microcontroller. The table below summarizes the errata and lists the affected revisions. See the data sheet for more details.

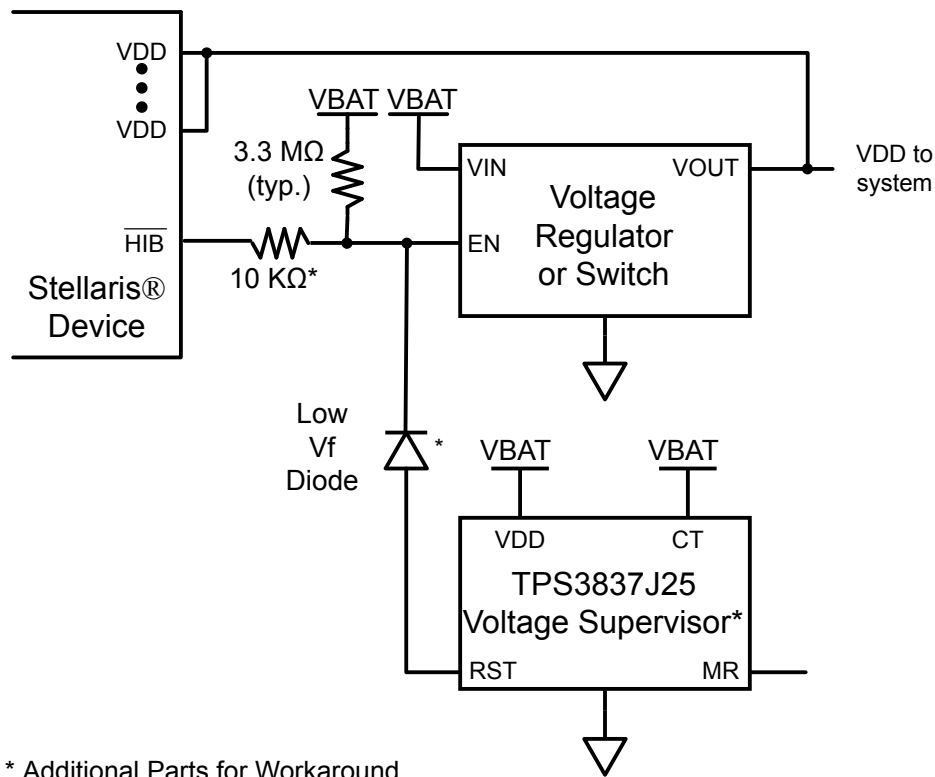
Figure 1. Workaround Circuit to Ensure Initial Power Up

If V_{DD} is not powered when voltage is first applied to V_{BAT} , the state of the Hibernation module is indeterminate and the \overline{HIB} signal may be asserted. In this indeterminate state, a lock condition can occur in which the Hibernation module waits for a power-on-reset, but that reset cannot occur until the module deasserts \overline{HIB} . This issue is related to the errata "Hibernation module may have higher current draw than specified in data sheet under certain conditions" on page 5.

The workaround implementation depends on the system-level power supply configuration. For systems that use a battery as the primary power source, an external voltage supervisor (TPS383J25DBV or similar) circuit can be added to force the V_{DD} power supply to start when the battery voltage is first applied (see Figure 1). The voltage supervisor requires only 220 nA and

generates a 200-ms positive pulse to turn on the V_{DD} regulator and activate the microcontroller's internal POR circuit.

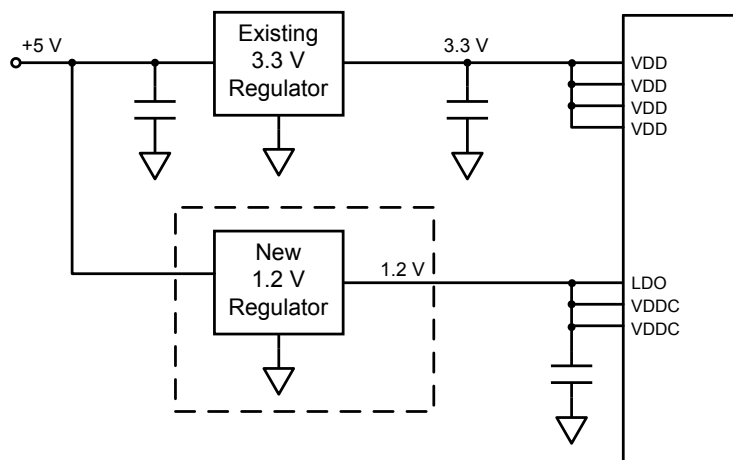
Figure 2. Configuration of External Regulator

Incorrect power sequencing during power up can disrupt operation and potentially cause device failure.

V_{DDC} must be applied approximately 50 μ s before V_{DD} . Normally V_{DDC} is controlled by the part's internal LDO voltage regulator. The workaround requires the addition of an external regulator (see Figure 2) to ensure that V_{DDC} sequencing requirements are met (see Figure 3). Recommended regulators include FAN1112SX (SOT223) and FAN2558S12X (SOT23-5).

This fix mitigates the on-chip power issue, but does not solve it completely. During development, the Flash memory should also be reprogrammed (using LMflash or another programming tool) at least once a week.
