Stellaris[®] LM3S5T36 RevB1 Errata

This document contains known errata at the time of publication for the Stellaris[®] LM3S5T36 microcontroller. The table below summarizes the errata and lists the affected revisions. See the data sheet for more details.

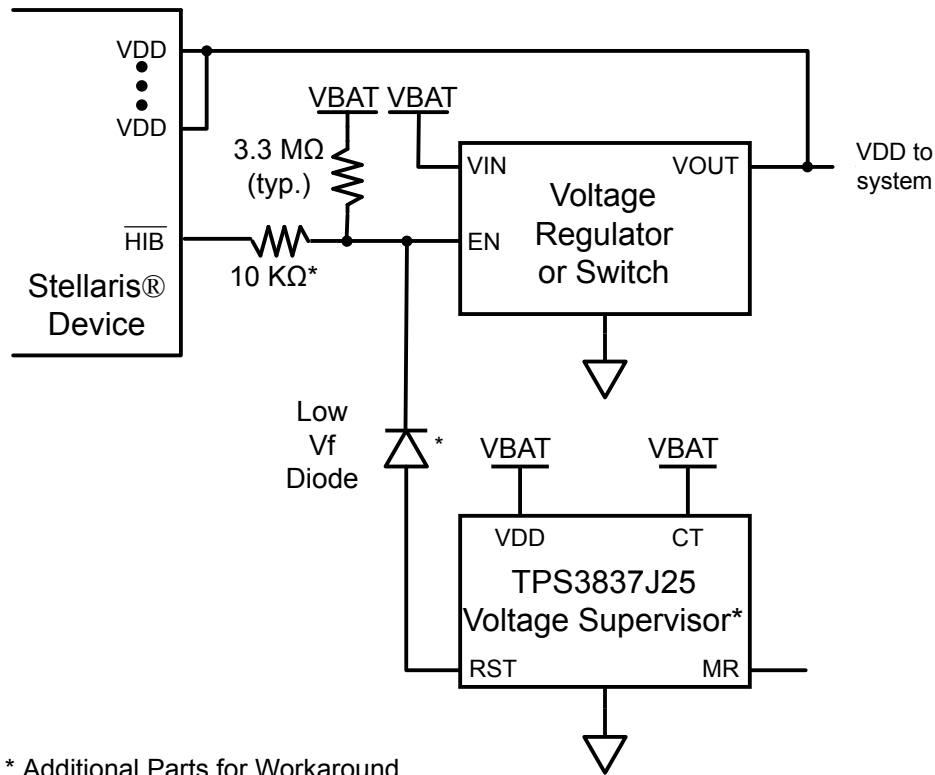
Figure 1. Workaround Circuit to Ensure Initial Power Up

If V_{DD} is not powered when voltage is first applied to V_{BAT} , the state of the Hibernation module is indeterminate and the \overline{HIB} signal may be asserted. In this indeterminate state, a lock condition can occur in which the Hibernation module waits for a power-on-reset, but that reset cannot occur until the module deasserts \overline{HIB} . This issue is related to the errata "Hibernation module may have higher current draw than specified in data sheet under certain conditions" on page 5.

The workaround implementation depends on the system-level power supply configuration. For systems that use a battery as the primary power source, an external voltage supervisor (TPS383J25DBV or similar) circuit can be added to force the V_{DD} power supply to start when the battery voltage is first applied (see Figure 1). The voltage supervisor requires only 220 nA and

generates a 200-ms positive pulse to turn on the V_{DD} regulator and activate the microcontroller's internal POR circuit.

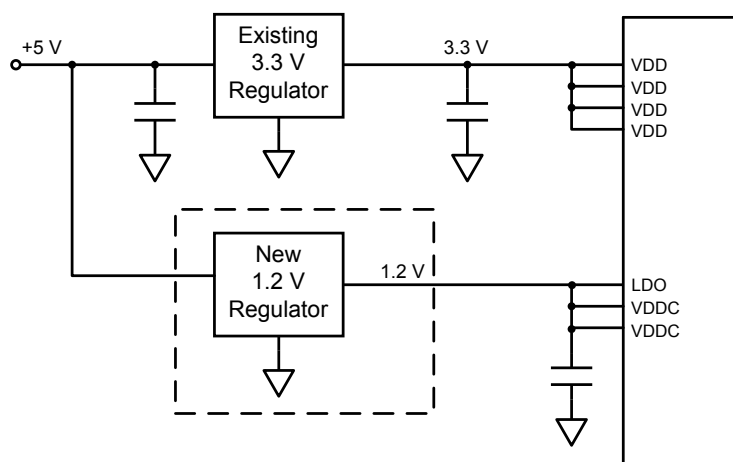
Figure 2. Configuration of External Regulator

Incorrect power sequencing during power up can disrupt operation and potentially cause device failure.

V_{DDC} must be applied approximately 50 μ s before V_{DD} . Normally V_{DDC} is controlled by the part's internal LDO voltage regulator. The workaround requires the addition of an external regulator (see Figure 2) to ensure that V_{DDC} sequencing requirements are met (see Figure 3). Recommended regulators include FAN1112SX (SOT223) and FAN2558S12X (SOT23-5).

This fix mitigates the on-chip power issue, but does not solve it completely. During development, the Flash memory should also be reprogrammed (using LMflash or another programming tool) at least once a week.
