Stellaris[®] LM3S5Y36 RevB1 Errata

This document contains known errata at the time of publication for the Stellaris[®] LM3S5Y36 microcontroller. The table below summarizes the errata and lists the affected revisions. See the data sheet for more details.

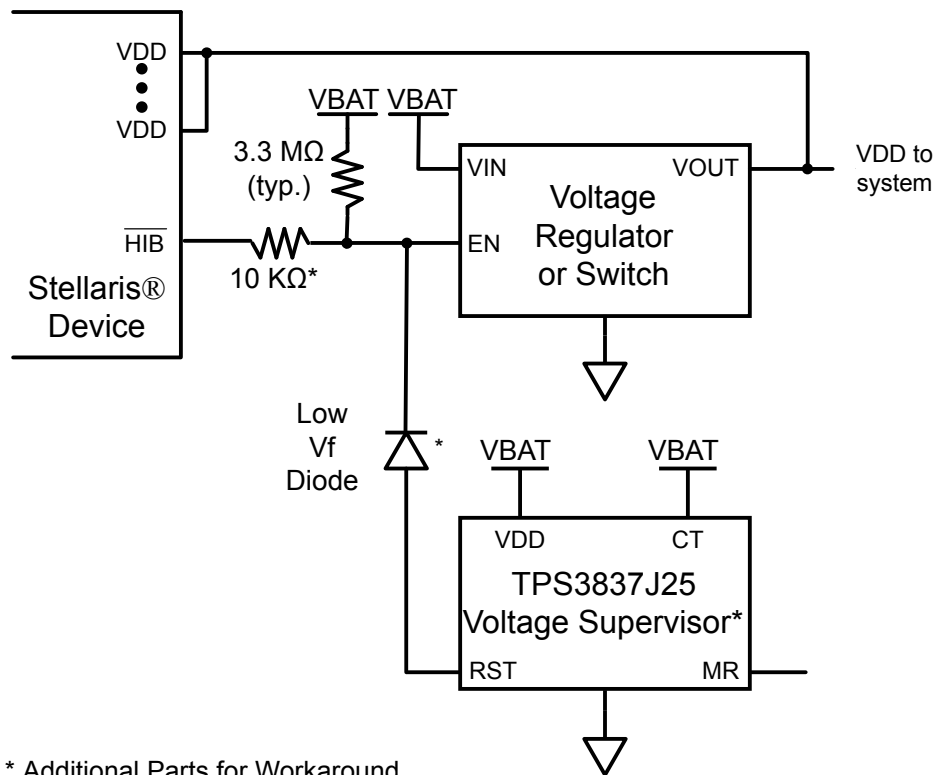
Figure 1. Workaround Circuit to Ensure Initial Power Up

If V_{DD} is not powered when voltage is first applied to V_{BAT} , the state of the Hibernation module is indeterminate and the \overline{HIB} signal may be asserted. In this indeterminate state, a lock condition can occur in which the Hibernation module waits for a power-on-reset, but that reset cannot occur until the module deasserts \overline{HIB} . This issue is related to the errata "Hibernation module may have higher current draw than specified in data sheet under certain conditions" on page 5.

The workaround implementation depends on the system-level power supply configuration. For systems that use a battery as the primary power source, an external voltage supervisor (TPS383J25DBV or similar) circuit can be added to force the V_{DD} power supply to start when the battery voltage is first applied (see Figure 1). The voltage supervisor requires only 220 nA and

generates a 200-ms positive pulse to turn on the V_{DD} regulator and activate the microcontroller's internal POR circuit.
