Stellaris[®] LM3S1P51 RevB1 Errata

This document contains known errata at the time of publication for the Stellaris[®] LM3S1P51 microcontroller. The table below summarizes the errata and lists the affected revisions. See the data sheet for more details.

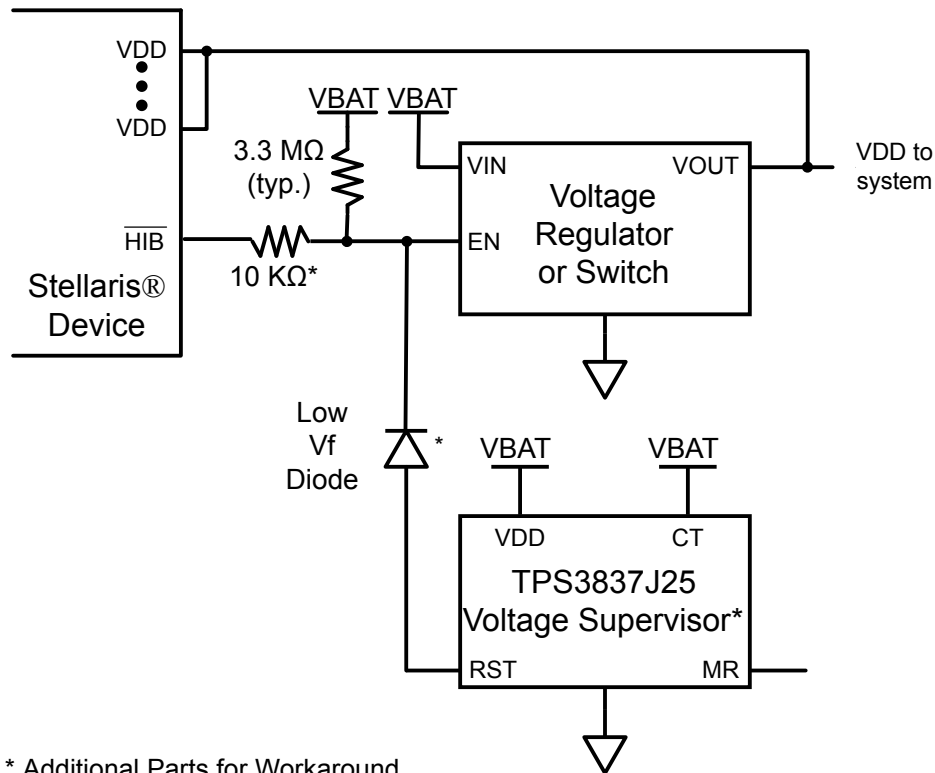
Figure 1. Workaround Circuit to Ensure Initial Power Up

3.2 Hibernate POR may not reset the Hibernation module until V_{DD} is applied

If V_{DD} is not powered when voltage is first applied to V_{BAT}, the state of the Hibernation module is indeterminate and the $\overline{\text{HIB}}$ signal may be asserted. In this indeterminate state, a lock condition can occur in which the Hibernation module waits for a power-on-reset, but that reset cannot occur until the module deasserts $\overline{\text{HIB}}$. This issue is related to the errata "Hibernation module may have higher current draw than specified in data sheet under certain conditions" on page 6.

The workaround implementation depends on the system-level power supply configuration. For systems that use a battery as the primary power source, an external voltage supervisor (TPS383J25DBV or similar) circuit can be added to force the V_{DD} power supply to start when the battery voltage is first applied (see Figure 1). The voltage supervisor requires only 220 nA and generates a 200-ms positive pulse to turn on the V_{DD} regulator and activate the microcontroller's internal POR circuit.

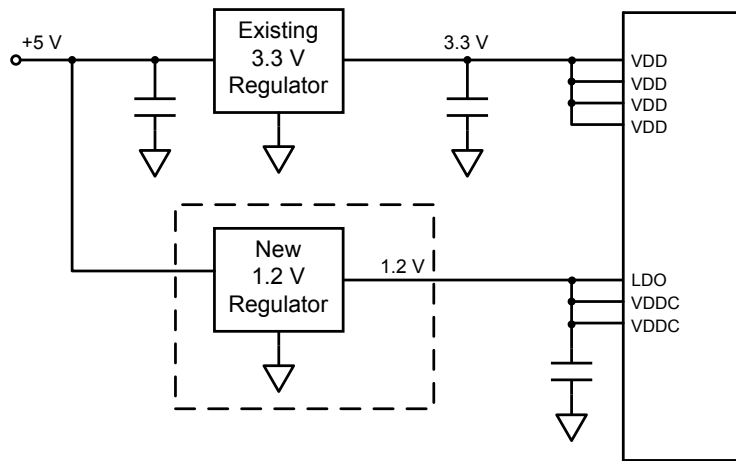
Figure 6. Configuration of External Regulator

Incorrect power sequencing during power up can disrupt operation and potentially cause device failure.

V_{DDC} must be applied approximately 50 μs before V_{DD} . Normally V_{DDC} is controlled by the part's internal LDO voltage regulator. The workaround requires the addition of an external regulator (see Figure 6) to ensure that V_{DDC} sequencing requirements are met (see Figure 7). A recommended regulator is the TI TPS73101DBVR.

This fix mitigates the on-chip power issue, but does not solve it completely. During development, the Flash memory should also be reprogrammed (using LMFlash or another programming tool) at least once a week.
