Stellaris[®] LM3S5P31 RevB1 Errata

This document contains known errata at the time of publication for the Stellaris[®] LM3S5P31 microcontroller. The table below summarizes the errata and lists the affected revisions. See the data sheet for more details.

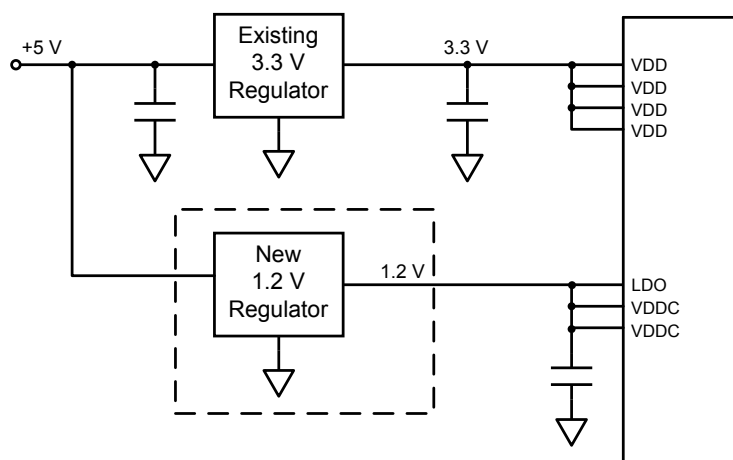
Figure 2. Configuration of External Regulator

Incorrect power sequencing during power up can disrupt operation and potentially cause device failure.

V_{DDC} must be applied approximately 50 μ s before V_{DD} . Normally V_{DDC} is controlled by the part's internal LDO voltage regulator. The workaround requires the addition of an external regulator (see Figure 2) to ensure that V_{DDC} sequencing requirements are met (see Figure 3). Recommended regulators include FAN1112SX (SOT223) and FAN2558S12X (SOT23-5).

This fix mitigates the on-chip power issue, but does not solve it completely. During development, the Flash memory should also be reprogrammed (using LMflash or another programming tool) at least once a week.
