## Stellaris<sup>®</sup> LM3S5R36 RevB1 Errata

This document contains known errata at the time of publication for the Stellaris<sup>®</sup> LM3S5R36 microcontroller. The table below summarizes the errata and lists the affected revisions. See the data sheet for more details.

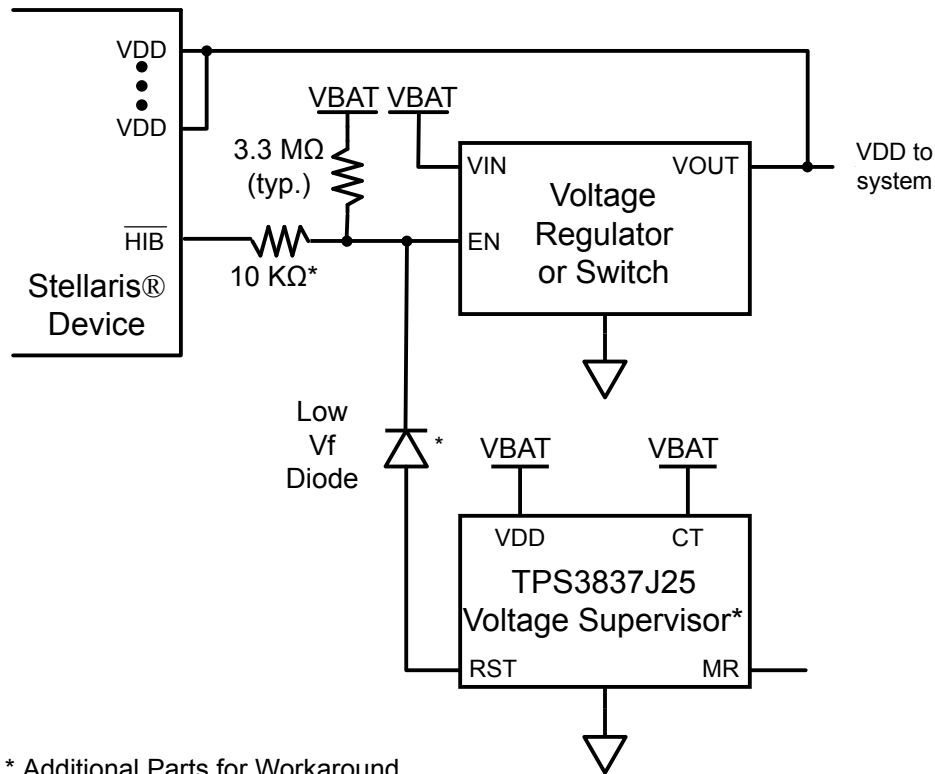
**Figure 1. Workaround Circuit to Ensure Initial Power Up**

If V<sub>DD</sub> is not powered when voltage is first applied to V<sub>BAT</sub>, the state of the Hibernation module is indeterminate and the  $\overline{\text{HIB}}$  signal may be asserted. In this indeterminate state, a lock condition can occur in which the Hibernation module waits for a power-on-reset, but that reset cannot occur until

the module deasserts  $\overline{\text{HIB}}$ . This issue is related to the errata “Hibernation module may have higher current draw than specified in data sheet under certain conditions” on page 5.

The workaround implementation depends on the system-level power supply configuration. For systems that use a battery as the primary power source, an external voltage supervisor (TPS383J25DBV or similar) circuit can be added to force the  $V_{DD}$  power supply to start when the battery voltage is first applied (see Figure 1). The voltage supervisor requires only 220 nA and generates a 200-ms positive pulse to turn on the  $V_{DD}$  regulator and activate the microcontroller's internal POR circuit.

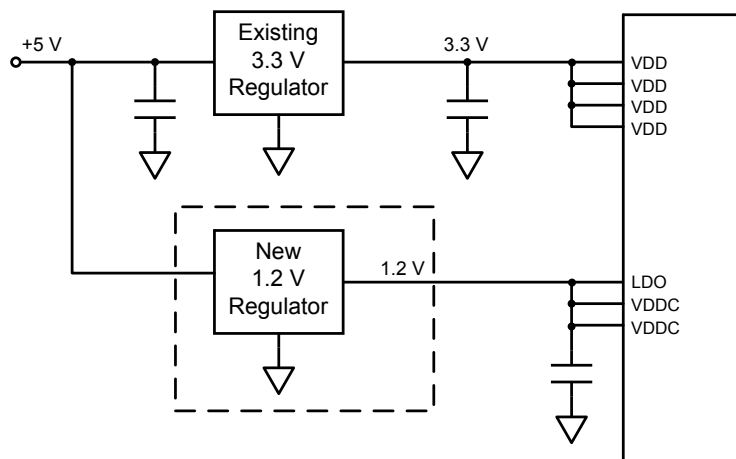
**Figure 2. Configuration of External Regulator**

Incorrect power sequencing during power up can disrupt operation and potentially cause device failure.

$V_{DDC}$  must be applied approximately 50  $\mu$ s before  $V_{DD}$ . Normally  $V_{DDC}$  is controlled by the part's internal LDO voltage regulator. The workaround requires the addition of an external regulator (see Figure 2) to ensure that  $V_{DDC}$  sequencing requirements are met (see Figure 3). Recommended regulators include FAN1112SX (SOT223) and FAN2558S12X (SOT23-5).

This fix mitigates the on-chip power issue, but does not solve it completely. During development, the Flash memory should also be reprogrammed (using LMflash or another programming tool) at least once a week.
