Stellaris[®] LM3S1W16 RevB1 Errata

This document contains known errata at the time of publication for the Stellaris[®] LM3S1W16 microcontroller. The table below summarizes the errata and lists the affected revisions. See the data sheet for more details.

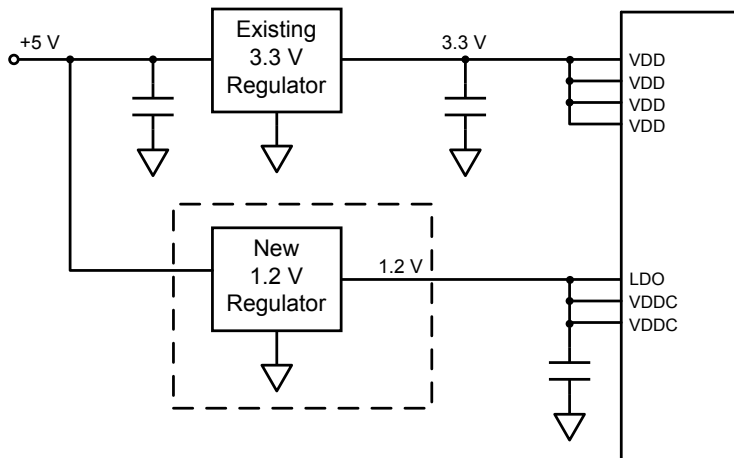
Figure 2. Configuration of External Regulator

9.1 Power-on event may disrupt operation

Incorrect power sequencing during power up can disrupt operation and potentially cause device failure.

V_{DDC} must be applied approximately 50 μ s before V_{DD} . Normally V_{DDC} is controlled by the part's internal LDO voltage regulator. The workaround requires the addition of an external regulator (see Figure 2) to ensure that V_{DDC} sequencing requirements are met (see Figure 3). Recommended regulators include FAN1112SX (SOT223) and FAN2558S12X (SOT23-5).

This fix mitigates the on-chip power issue, but does not solve it completely. During development, the Flash memory should also be reprogrammed (using LMflash or another programming tool) at least once a week.
