Stellaris[®] LM3S1N11 RevB1 Errata

This document contains known errata at the time of publication for the Stellaris[®] LM3S1N11 microcontroller. The table below summarizes the errata and lists the affected revisions. See the data sheet for more details.

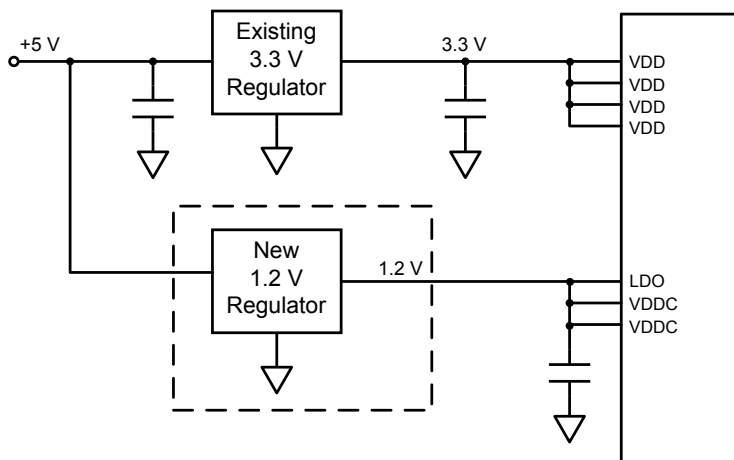
Figure 2. Configuration of External Regulator

Incorrect power sequencing during power up can disrupt operation and potentially cause device failure.

V_{DDC} must be applied approximately 50 μ s before V_{DD} . Normally V_{DDC} is controlled by the part's internal LDO voltage regulator. The workaround requires the addition of an external regulator (see Figure 2) to ensure that V_{DDC} sequencing requirements are met (see Figure 3). Recommended regulators include FAN1112SX (SOT223) and FAN2558S12X (SOT23-5).

This fix mitigates the on-chip power issue, but does not solve it completely. During development, the Flash memory should also be reprogrammed (using LMflash or another programming tool) at least once a week.
