Stellaris[®] LM3S5651 RevB1 Errata

This document contains known errata at the time of publication for the Stellaris[®] LM3S5651 microcontroller. The table below summarizes the errata and lists the affected revisions. See the data sheet for more details.

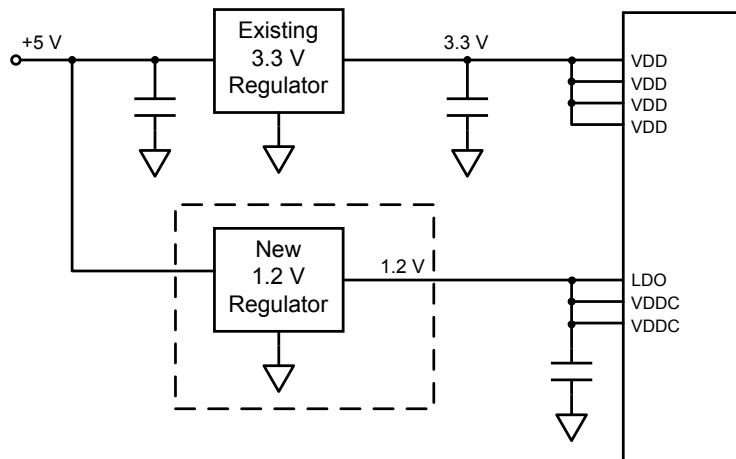
Figure 2. Configuration of External Regulator

Incorrect power sequencing during power up can disrupt operation and potentially cause device failure.

V_{DDC} must be applied approximately 50 μ s before V_{DD} . Normally V_{DDC} is controlled by the part's internal LDO voltage regulator. The workaround requires the addition of an external regulator (see Figure 2) to ensure that V_{DDC} sequencing requirements are met (see Figure 3). Recommended regulators include FAN1112SX (SOT223) and FAN2558S12X (SOT23-5).

This fix mitigates the on-chip power issue, but does not solve it completely. During development, the Flash memory should also be reprogrammed (using LMflash or another programming tool) at least once a week.
