Stellaris[®] LM3S9997 RevB1 Errata

This document contains known errata at the time of publication for the Stellaris[®] LM3S9997 microcontroller. The table below summarizes the errata and lists the affected revisions. See the data sheet for more details.

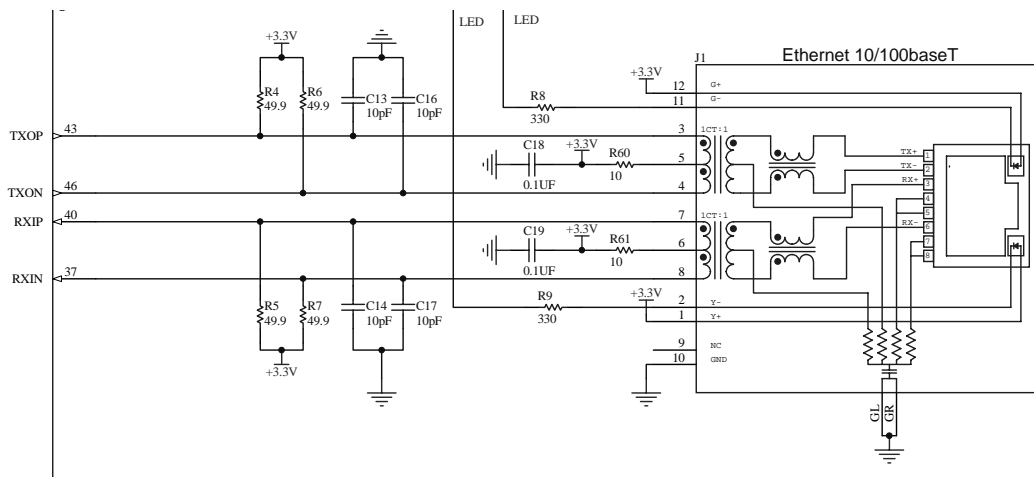
Figure 2. Recommended Center-Tap Connections

The microcontroller experiences some packet loss with Ethernet cables longer than 50 meters in normal operating conditions.

1. Add 10 Ω resistor to the center-tap of the transformer as shown in the figure. These resistors should be replaced by a direct connection for silicon that has this item fixed.
2. Continue using the recommended circuit, but limit cable lengths to 50 meters.
