Abstract

This application note explains how ULINK^{pro} is used to identify sporadic errors that were caused by misconfigured hardware. It shows how the advanced debug features of the Arm Cortex-M architecture and the trace adapter helped to find the root cause of the problem that was not related to the application software (in this case a network stack) but caused by a wrong timing configuration of a Flash accelerator.

Introduction

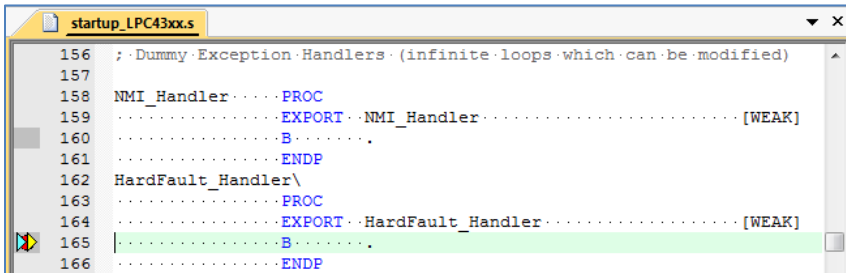
This stops the program execution when the hard fault happens. Otherwise, the trace will contain millions of the Branch (B) instruction to itself. Stopping on the fault will indicate where the error has occurred.

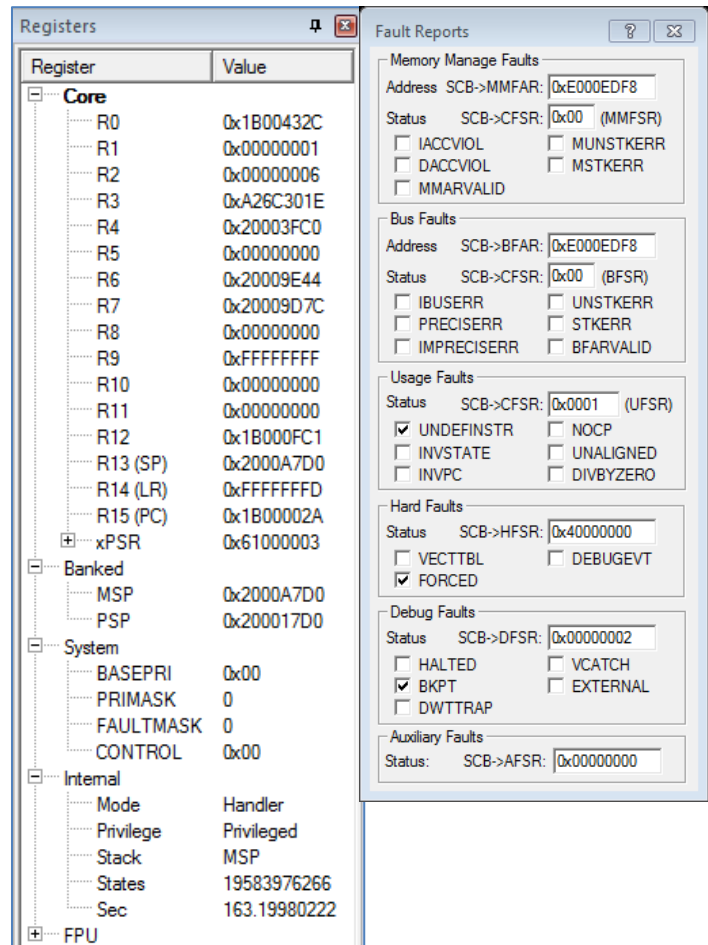
3. Run the program.
4. After the breakpoint is hit, examine the [Fault Reports](#) window. It indicates that an undefined instruction caused the fault (UNDEFINSTR flag).
5. Examine the [Registers](#) window to determine the stack frame used. Shown here, LR = 0xFFFF_FFFD which is the EXC_RETURN value that indicates that PSP was used for stacking.
6. PSP equals 0x2000_17D0.

Usage Faults	
Status SCB->CFSR:	0x0001 (UFSR)
<input checked="" type="checkbox"/> UNDEFINSTR	<input type="checkbox"/> NOCP
<input type="checkbox"/> INVSTATE	<input type="checkbox"/> UNALIGNED
<input type="checkbox"/> INVPC	<input type="checkbox"/> DIVBYZERO

Hard Faults	
Status SCB->HFSR:	0x40000000
<input type="checkbox"/> VECTTBL	<input type="checkbox"/> DEBUGEVT
<input checked="" type="checkbox"/> FORCED

10. Return Address 0x1A05_2112 indicates the instruction causing the fault.
11. Examine the instruction at address 0x1A05_2112 in the Disassembly window. This is the instruction that caused the fault. It is located in the internal Flash that is not used and contains 0xFFFF_FFFF (erased Flash value). Therefore, a hard fault due to an undefined instruction occurs.

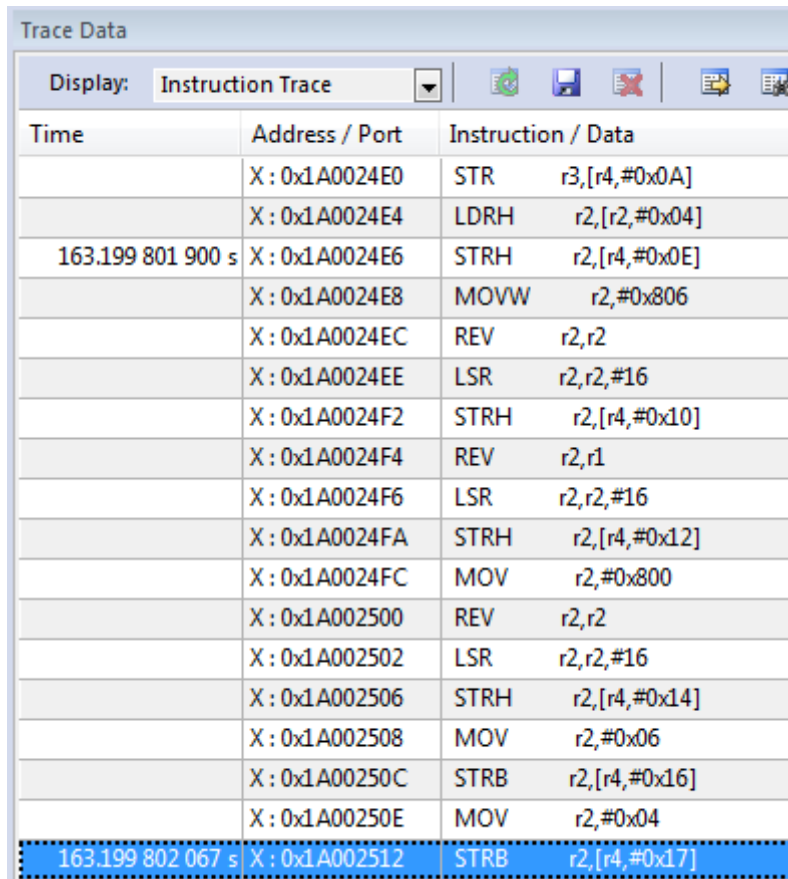
The STRB instruction located at 0x1A00_2512 at the bottom of the **Trace Data** window is the last execution executed according to the ETM buffer.

The last instruction that seems to be executed successfully, is `MOV R2, #0x04` at address `0x1A00_250E`. The green bar shows executed instructions and is part of code coverage. Code coverage indicates if an instruction was executed or not.

The next instruction `STRB` at address `0x1A00_2512` seems to trigger the fault. But why would the `STRB` cause an undefined instruction at a different address than reported in faults? Furthermore, the `MOV R2, #0x04` instruction is not really executed since the register `R2` contains a different value (`R2 = 0x06`).

It seems that the `MOV` instruction was not fetched correctly from Flash and some other instruction was decoded. Most likely a branch to the address where the fault is reported.

Also, the 32-bit `MOV` instruction crosses a 128-bit boundary, which is another indicator that a new Flash line needs to be fetched. It is speculated that the first 16-bits of the instruction were fetched correctly (value `0xF04F`) and the second 16-bits incorrectly as `0xBE00` (and not `0x0206`).

This would effectively change the `MOV R2, #0x04` instruction (opcode `0xF04F0204`) to `B 0x1A052112` opcode (`0xF04FBE00`) and explain why the allegedly executed `MOV` did not take place but rather a branch to an undefined instruction was executed.
