Stellaris[®] LM3S3W26 RevB1 Errata

This document contains known errata at the time of publication for the Stellaris[®] LM3S3W26 microcontroller. The table below summarizes the errata and lists the affected revisions. See the data sheet for more details.

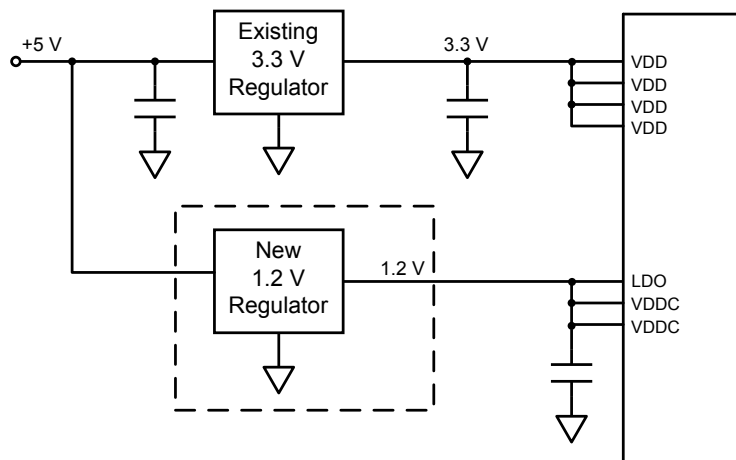
Figure 2. Configuration of External Regulator

Incorrect power sequencing during power up can disrupt operation and potentially cause device failure.

V_{DDC} must be applied approximately 50 μ s before V_{DD} . Normally V_{DDC} is controlled by the part's internal LDO voltage regulator. The workaround requires the addition of an external regulator (see Figure 2) to ensure that V_{DDC} sequencing requirements are met (see Figure 3). Recommended regulators include FAN1112SX (SOT223) and FAN2558S12X (SOT23-5).
