Stellaris[®] LM3S5956 RevB1 Errata

This document contains known errata at the time of publication for the Stellaris[®] LM3S5956 microcontroller. The table below summarizes the errata and lists the affected revisions. See the data sheet for more details.

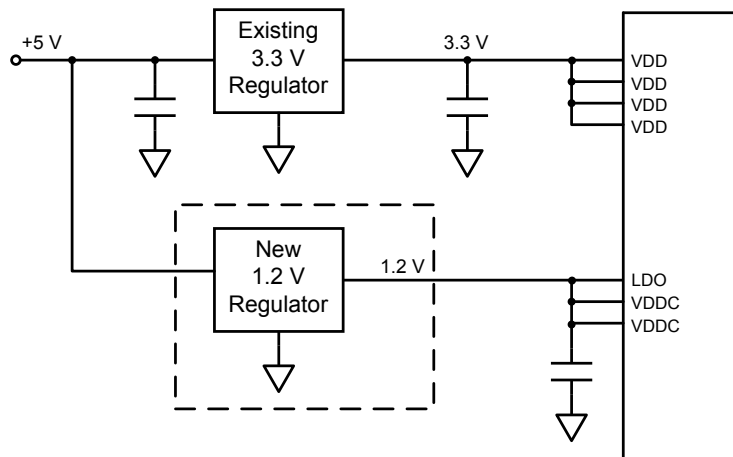
Figure 2. Configuration of External Regulator

Incorrect power sequencing during power up can disrupt operation and potentially cause device failure.

V_{DDC} must be applied approximately 50 μ s before V_{DD} . Normally V_{DDC} is controlled by the part's internal LDO voltage regulator. The workaround requires the addition of an external regulator (see Figure 2) to ensure that V_{DDC} sequencing requirements are met (see Figure 3). Recommended regulators include FAN1112SX (SOT223) and FAN2558S12X (SOT23-5).

This fix mitigates the on-chip power issue, but does not solve it completely. During development, the Flash memory should also be reprogrammed (using LMflash or another programming tool) at least once a week.
