Stellaris[®] LM3S5K36 RevB1 Errata

This document contains known errata at the time of publication for the Stellaris[®] LM3S5K36 microcontroller. The table below summarizes the errata and lists the affected revisions. See the data sheet for more details.

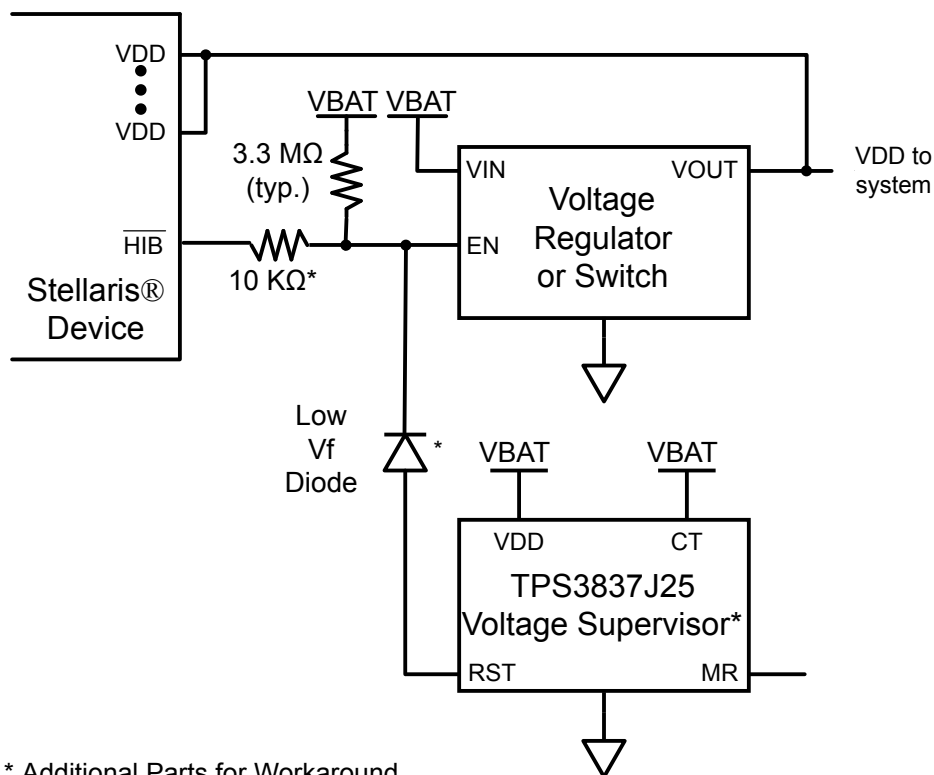
Figure 1. Workaround Circuit to Ensure Initial Power Up

If V_{DD} is not powered when voltage is first applied to V_{BAT} , the state of the Hibernation module is indeterminate and the \overline{HIB} signal may be asserted. In this indeterminate state, a lock condition can occur in which the Hibernation module waits for a power-on-reset, but that reset cannot occur until the module deasserts \overline{HIB} . This issue is related to the errata "Hibernation module may have higher current draw than specified in data sheet under certain conditions" on page 5.

The workaround implementation depends on the system-level power supply configuration. For systems that use a battery as the primary power source, an external voltage supervisor (TPS383J25DBV or similar) circuit can be added to force the V_{DD} power supply to start when the battery voltage is first applied (see Figure 1). The voltage supervisor requires only 220 nA and

generates a 200-ms positive pulse to turn on the V_{DD} regulator and activate the microcontroller's internal POR circuit.
