# XC2300 Derivatives

16/32-Bit Single-Chip Microcontroller with  
32-Bit Performance

**Edition 22.08.2008**

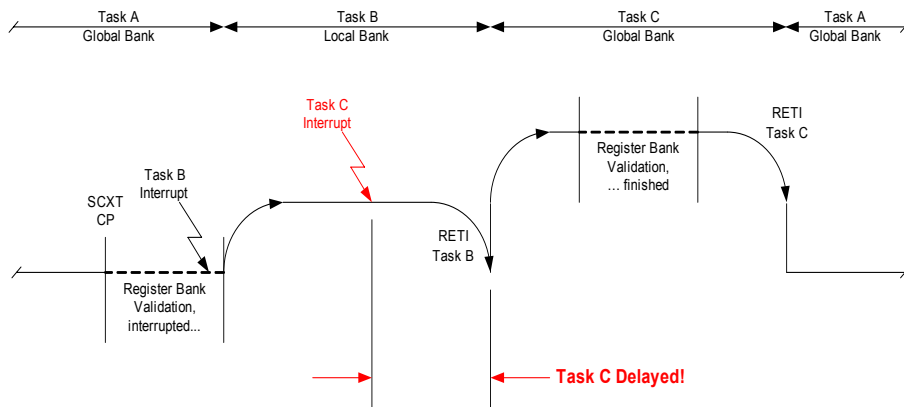
00<sub>B</sub>) to automatically use the **global** bank via the bank selection registers BNKSEL0...3 (i.e. the interrupting routine has a priority level  $\geq 13$ )

In this case service of this interrupt request (for Task C) is delayed until bit field PSW.BANK becomes 00<sub>B</sub> after executing the RETI instruction at the end of the routine (Task B) using the local bank.

**Figure 1 Example for Case 2: Interrupt Service for Task C delayed**

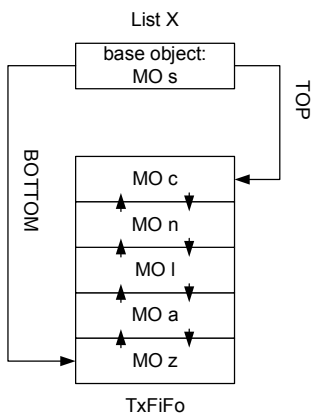
After the successful transmission of a Tx FIFO element, a Tx overflow interrupt is generated if the FIFO base object fulfils these conditions:

**Figure 2** FIFO structure

If Tx FIFO overflow interrupt needed, take the FIFO base object out of the circular list of the Tx message objects. That is to say, just use the FIFO base object for FIFO control, but not to store a Tx message.

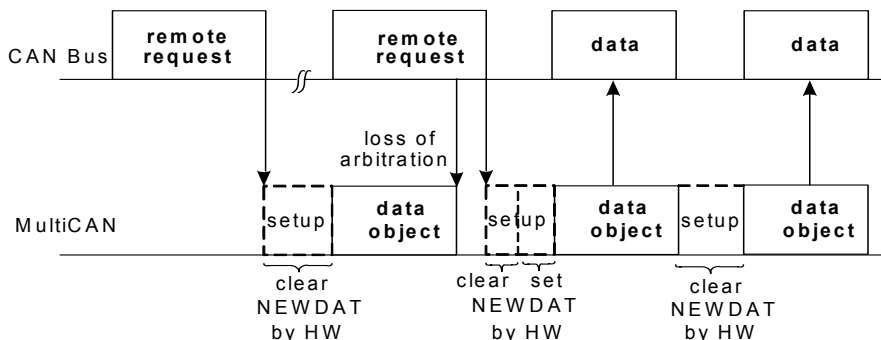
When the appropriate message object (data frame) triggered by the first remote frame wins the arbitration, it will be sent out and NEWDAT is not reset. This leads to an additional data frame, that will be sent by this message object (clearing NEWDAT).

There will, however, not be more data frames than there are corresponding remote requests.

**Figure 4 Loss of Arbitration**
