## Stellaris<sup>®</sup> LM3S5951 RevB1 Errata

This document contains known errata at the time of publication for the Stellaris<sup>®</sup> LM3S5951 microcontroller. The table below summarizes the errata and lists the affected revisions. See the data sheet for more details.

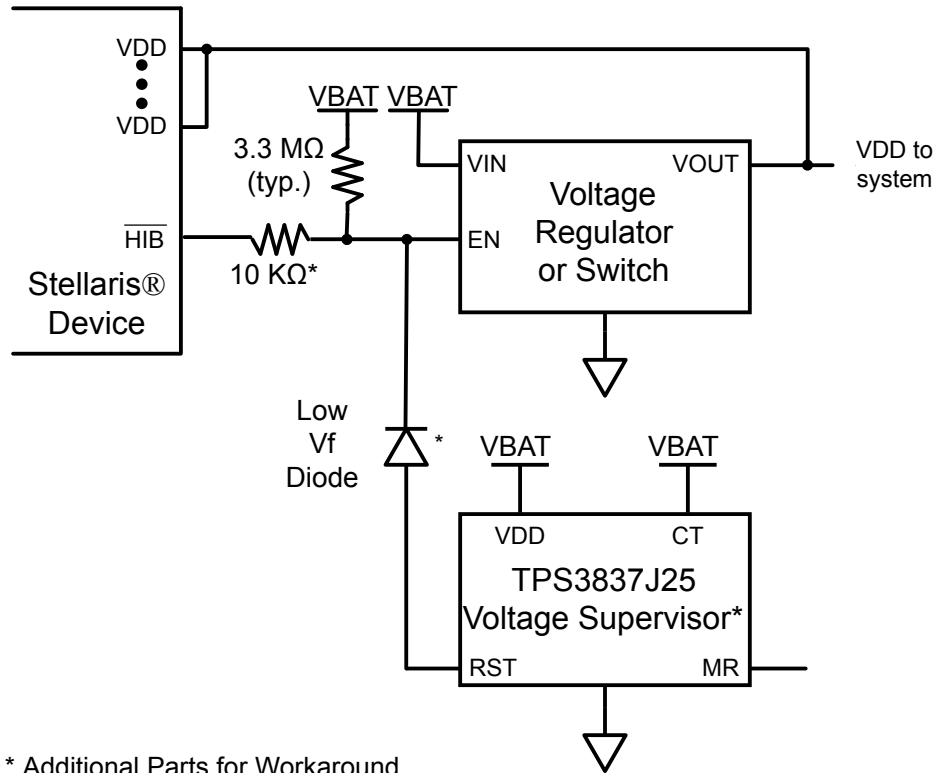
Figure 1. Workaround Circuit to Ensure Initial Power Up

If  $V_{DD}$  is not powered when voltage is first applied to  $V_{BAT}$ , the state of the Hibernation module is indeterminate and the  $\overline{HIB}$  signal may be asserted. In this indeterminate state, a lock condition can occur in which the Hibernation module waits for a power-on-reset, but that reset cannot occur until the module deasserts  $\overline{HIB}$ . This issue is related to the errata "Hibernation module may have higher current draw than specified in data sheet under certain conditions" on page 5.

The workaround implementation depends on the system-level power supply configuration. For systems that use a battery as the primary power source, an external voltage supervisor (TPS383J25DBV or similar) circuit can be added to force the  $V_{DD}$  power supply to start when the battery voltage is first applied (see Figure 1). The voltage supervisor requires only 220 nA and generates a 200-ms positive pulse to turn on the  $V_{DD}$  regulator and activate the microcontroller's internal POR circuit.

\* Additional Parts for Workaround

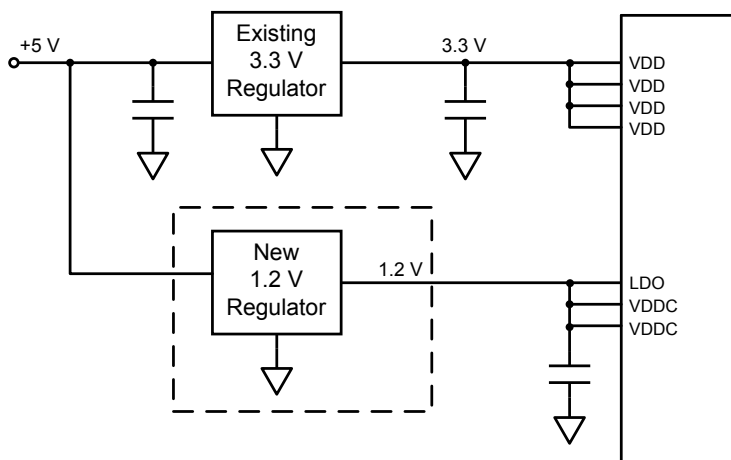
**Figure 2. Configuration of External Regulator**

Incorrect power sequencing during power up can disrupt operation and potentially cause device failure.

$V_{DDC}$  must be applied approximately 50  $\mu$ s before  $V_{DD}$ . Normally  $V_{DDC}$  is controlled by the part's internal LDO voltage regulator. The workaround requires the addition of an external regulator (see Figure 2) to ensure that  $V_{DDC}$  sequencing requirements are met (see Figure 3). Recommended regulators include FAN1112SX (SOT223) and FAN2558S12X (SOT23-5).

This fix mitigates the on-chip power issue, but does not solve it completely. During development, the Flash memory should also be reprogrammed (using LMflash or another programming tool) at least once a week.
