Stellaris[®] LM3S5R31 RevB1 Errata

This document contains known errata at the time of publication for the Stellaris[®] LM3S5R31 microcontroller. The table below summarizes the errata and lists the affected revisions. See the data sheet for more details.

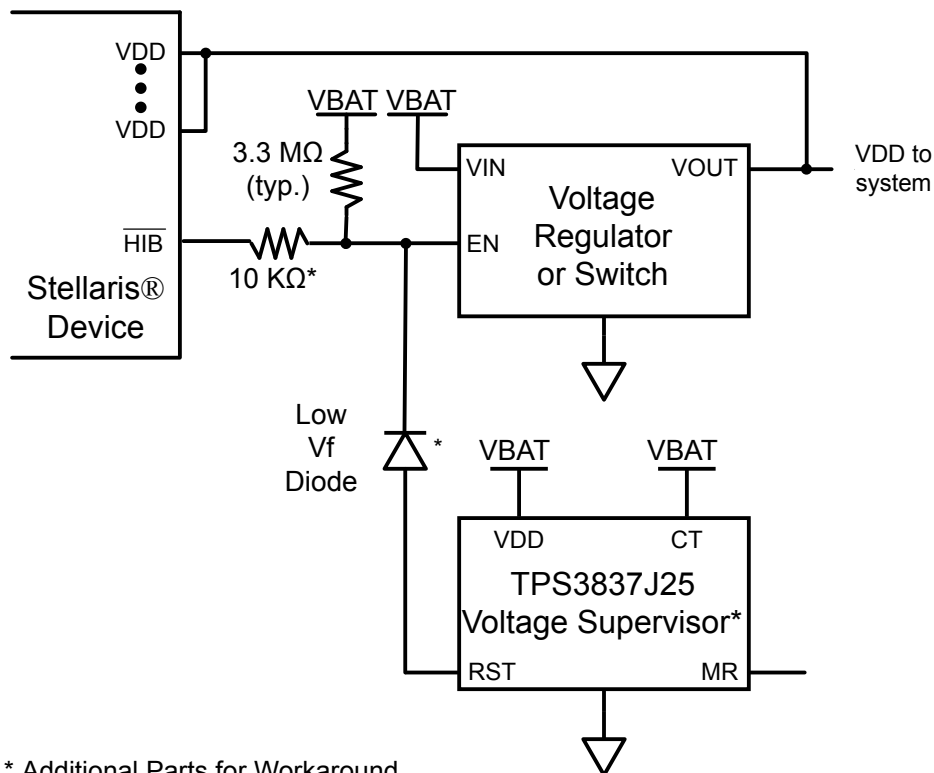
Figure 1. Workaround Circuit to Ensure Initial Power Up

If V_{DD} is not powered when voltage is first applied to V_{BAT} , the state of the Hibernation module is indeterminate and the \overline{HIB} signal may be asserted. In this indeterminate state, a lock condition can occur in which the Hibernation module waits for a power-on-reset, but that reset cannot occur until the module deasserts \overline{HIB} . This issue is related to the errata "Hibernation module may have higher current draw than specified in data sheet under certain conditions" on page 5.

The workaround implementation depends on the system-level power supply configuration. For systems that use a battery as the primary power source, an external voltage supervisor (TPS383J25DBV or similar) circuit can be added to force the V_{DD} power supply to start when the battery voltage is first applied (see Figure 1). The voltage supervisor requires only 220 nA and generates a 200-ms positive pulse to turn on the V_{DD} regulator and activate the microcontroller's internal POR circuit.

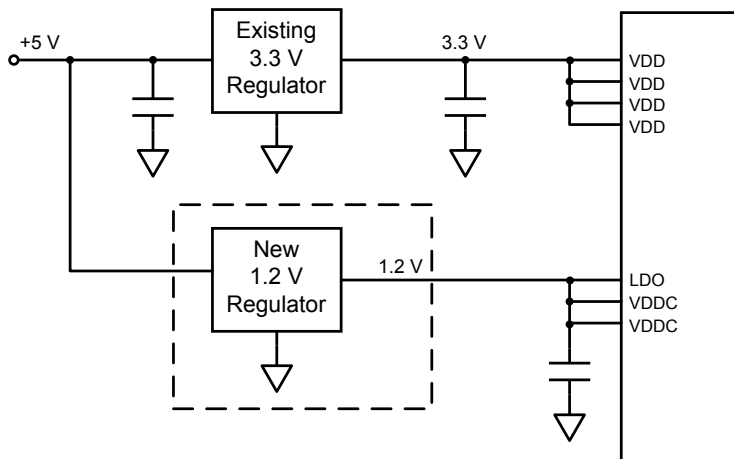
Figure 2. Configuration of External Regulator

Incorrect power sequencing during power up can disrupt operation and potentially cause device failure.

V_{DDC} must be applied approximately 50 μ s before V_{DD} . Normally V_{DDC} is controlled by the part's internal LDO voltage regulator. The workaround requires the addition of an external regulator (see Figure 2) to ensure that V_{DDC} sequencing requirements are met (see Figure 3). Recommended regulators include FAN1112SX (SOT223) and FAN2558S12X (SOT23-5).

This fix mitigates the on-chip power issue, but does not solve it completely. During development, the Flash memory should also be reprogrammed (using LMflash or another programming tool) at least once a week.
