## Stellaris<sup>®</sup> LM3S1816 RevB1 Errata

This document contains known errata at the time of publication for the Stellaris<sup>®</sup> LM3S1816 microcontroller. The table below summarizes the errata and lists the affected revisions. See the data sheet for more details.

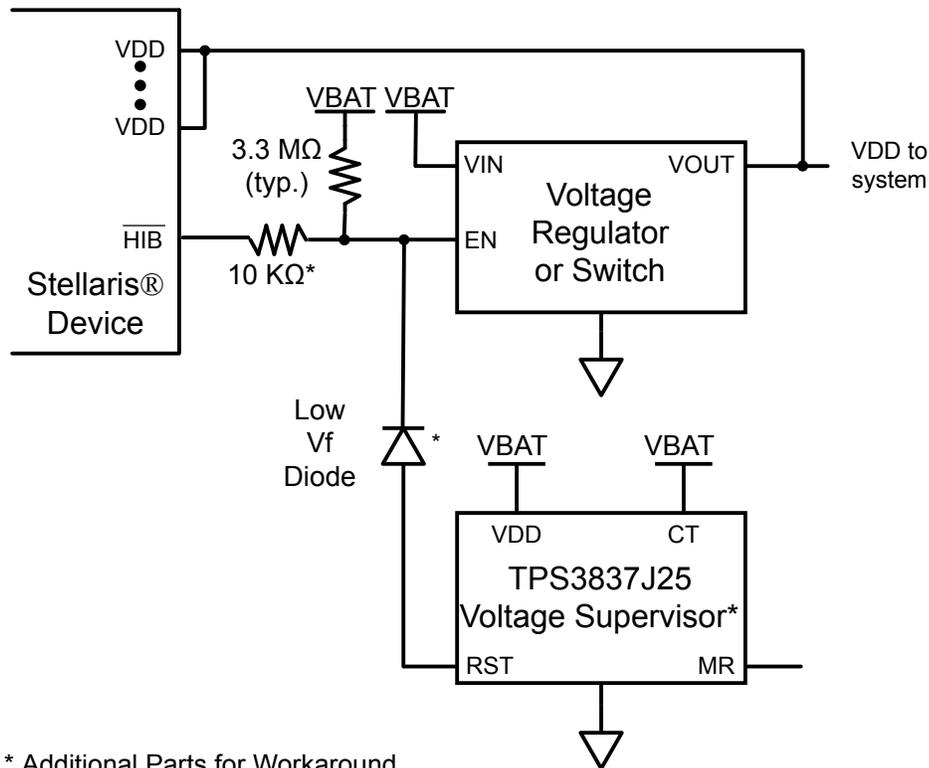
Figure 1. Workaround Circuit to Ensure Initial Power Up

If  $V_{DD}$  is not powered when voltage is first applied to  $V_{BAT}$ , the state of the Hibernation module is indeterminate and the  $\overline{HIB}$  signal may be asserted. In this indeterminate state, a lock condition can occur in which the Hibernation module waits for a power-on-reset, but that reset cannot occur until the module deasserts  $\overline{HIB}$ . This issue is related to the errata "Hibernation module may have higher current draw than specified in data sheet under certain conditions" on page 5.

The workaround implementation depends on the system-level power supply configuration. For systems that use a battery as the primary power source, an external voltage supervisor (TPS383J25DBV or similar) circuit can be added to force the  $V_{DD}$  power supply to start when the battery voltage is first applied (see Figure 1). The voltage supervisor requires only 220 nA and generates a 200-ms positive pulse to turn on the  $V_{DD}$  regulator and activate the microcontroller's internal POR circuit.

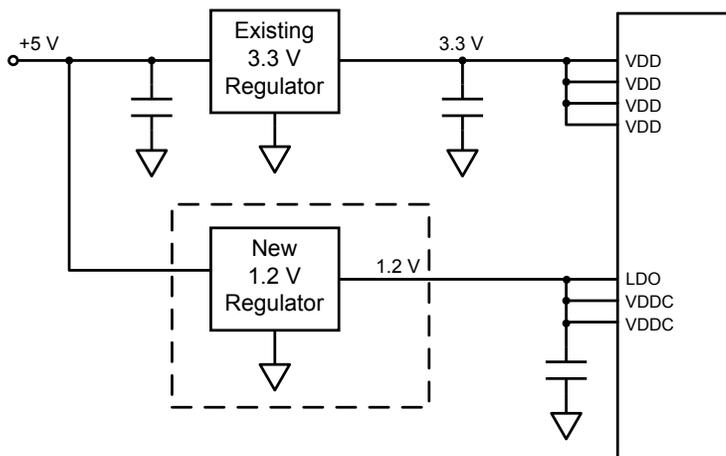
**Figure 2. Configuration of External Regulator**

Incorrect power sequencing during power up can disrupt operation and potentially cause device failure.

$V_{DDC}$  must be applied approximately 50  $\mu$ s before  $V_{DD}$ . Normally  $V_{DDC}$  is controlled by the part's internal LDO voltage regulator. The workaround requires the addition of an external regulator (see Figure 2) to ensure that  $V_{DDC}$  sequencing requirements are met (see Figure 3). Recommended regulators include FAN1112SX (SOT223) and FAN2558S12X (SOT23-5).

This fix mitigates the on-chip power issue, but does not solve it completely. During development, the Flash memory should also be reprogrammed (using LMflash or another programming tool) at least once a week.
