Stellaris[®] LM3S5K31 RevB1 Errata

This document contains known errata at the time of publication for the Stellaris[®] LM3S5K31 microcontroller. The table below summarizes the errata and lists the affected revisions. See the data sheet for more details.

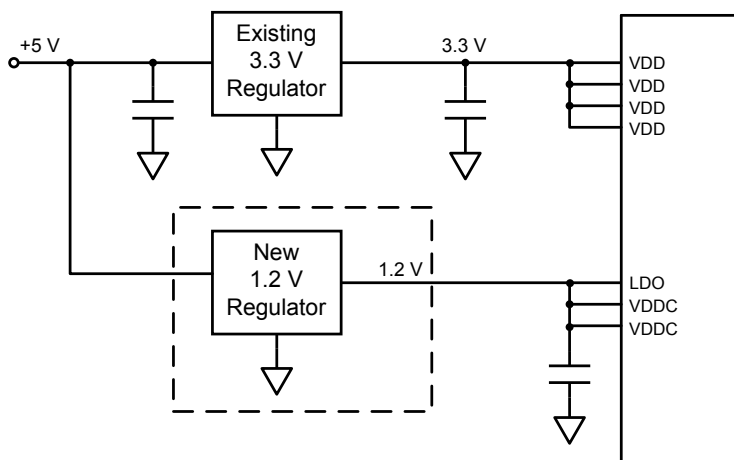
Figure 2. Configuration of External Regulator

Incorrect power sequencing during power up can disrupt operation and potentially cause device failure.

V_{DDC} must be applied approximately 50 μ s before V_{DD} . Normally V_{DDC} is controlled by the part's internal LDO voltage regulator. The workaround requires the addition of an external regulator (see Figure 2) to ensure that V_{DDC} sequencing requirements are met (see Figure 3). Recommended regulators include FAN1112SX (SOT223) and FAN2558S12X (SOT23-5).
