Stellaris® LM3S5P51 RevB1 Errata

This document contains known errata at the time of publication for the Stellaris® LM3S5P51 microcontroller. The table below summarizes the errata and lists the affected revisions. See the data sheet for more details.

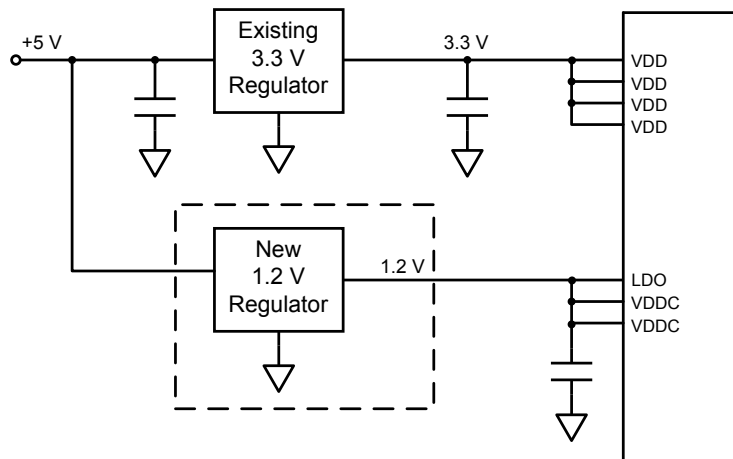
Figure 2. Configuration of External Regulator

Incorrect power sequencing during power up can disrupt operation and potentially cause device failure.

V_{DDC} must be applied approximately 50 μ s before V_{DD} . Normally V_{DDC} is controlled by the part's internal LDO voltage regulator. The workaround requires the addition of an external regulator (see Figure 2) to ensure that V_{DDC} sequencing requirements are met (see Figure 3). Recommended regulators include FAN1112SX (SOT223) and FAN2558S12X (SOT23-5).
