ES_LPC1850/30/20/10

Errata sheet LPC1850, LPC1830, LPC1820, LPC1810

Rev. 5 — 15 July 2013

Errata sheet

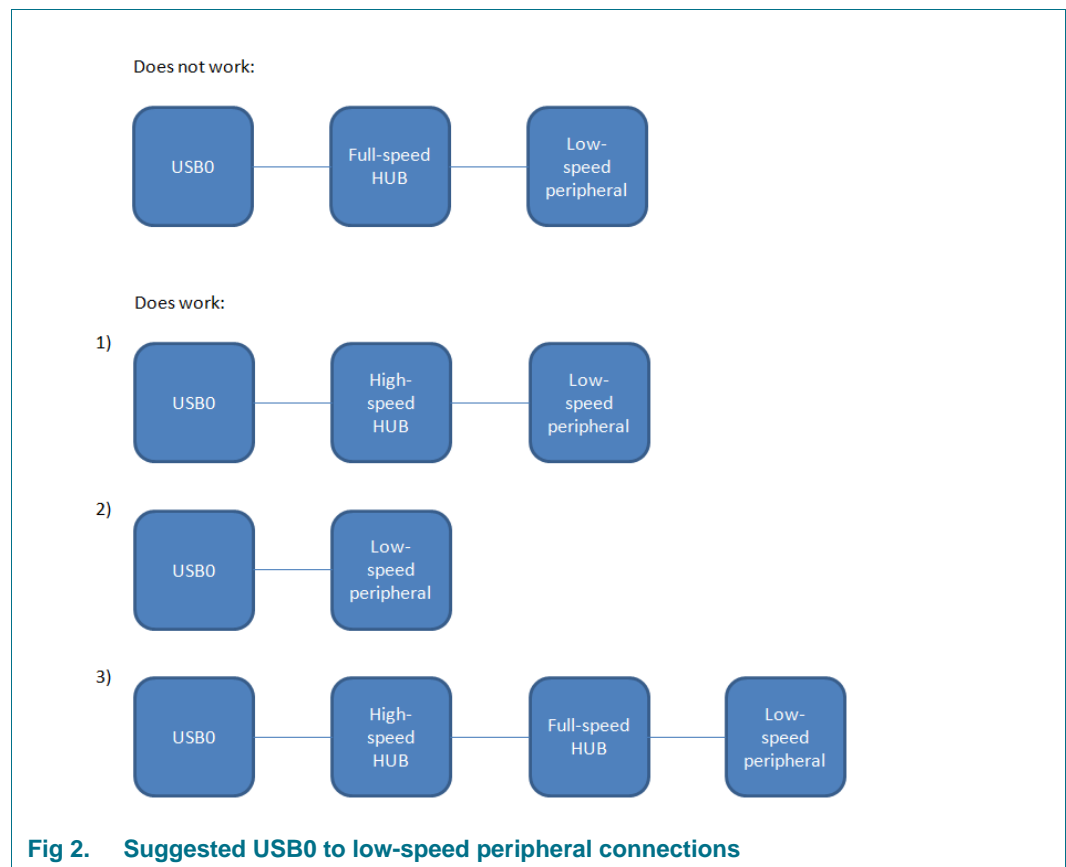
The USB controller called USB0 is unable to communicate with a low-speed USB peripheral in host mode when there is a full-speed hub directly connected to the USB0 port and a low-speed peripheral is connected in the tree somewhere below this full-speed hub. Only USB0 has this problem; the other USB controller, USB1 does not.

There is no work-around for this problem. It is suggested that the low-speed USB peripheral is either connected directly to USB0 or a high-speed hub is placed between that peripheral and USB0.
