## Stellaris<sup>®</sup> LM3S1P51 RevC Errata

This document contains known errata at the time of publication for the Stellaris<sup>®</sup> LM3S1P51 microcontroller. The table below summarizes the errata and lists the affected revisions. See the data sheet for more details.

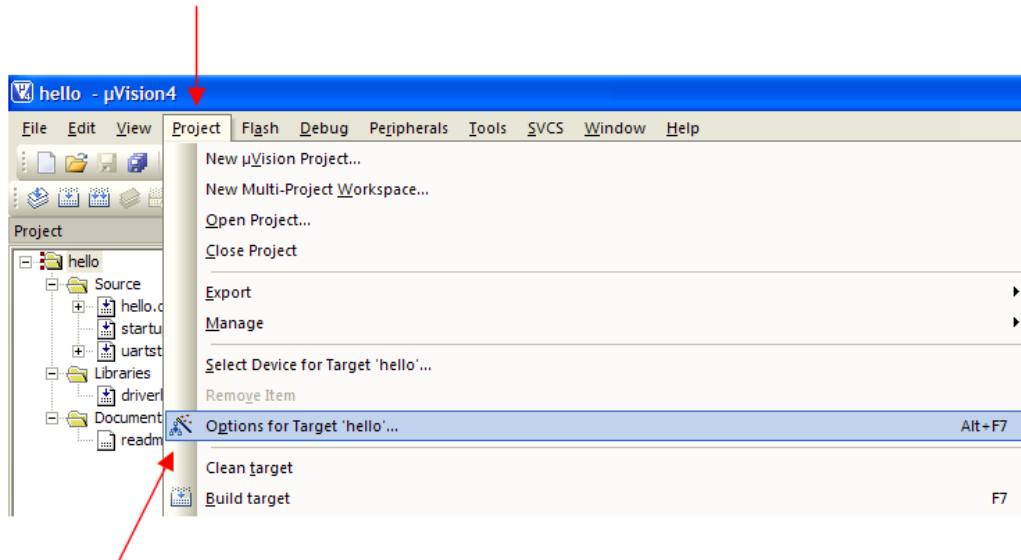
**Figure A-1. Navigating to the "Run to Main()" Option**

If the debugger is configured to simply reset/connect, it attempts to disassemble code in a protected region of Flash memory. The simple solution is to configure the debugger to "load/run to main". With this configuration, the patch code gets run and the Flash interrupt gets enabled. The PC runs to the main() function when the debugger starts. This option can be found in: Project □ Options for target '<project name>' as shown in Figure A-1 on page 18.

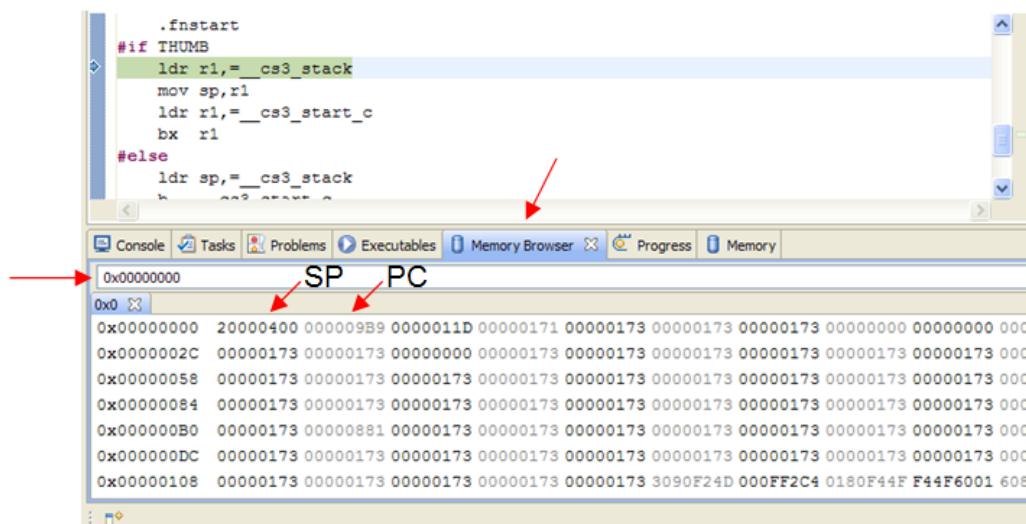
Figure A-5. Finding the Proper SP and PC to Use

Once the debugger is started, go to the “Memory Browser” window at the bottom of the screen and enter address 0x00000000. The first 2 locations show you the SP and PC for the patch as shown in Figure A-5 on page 22.

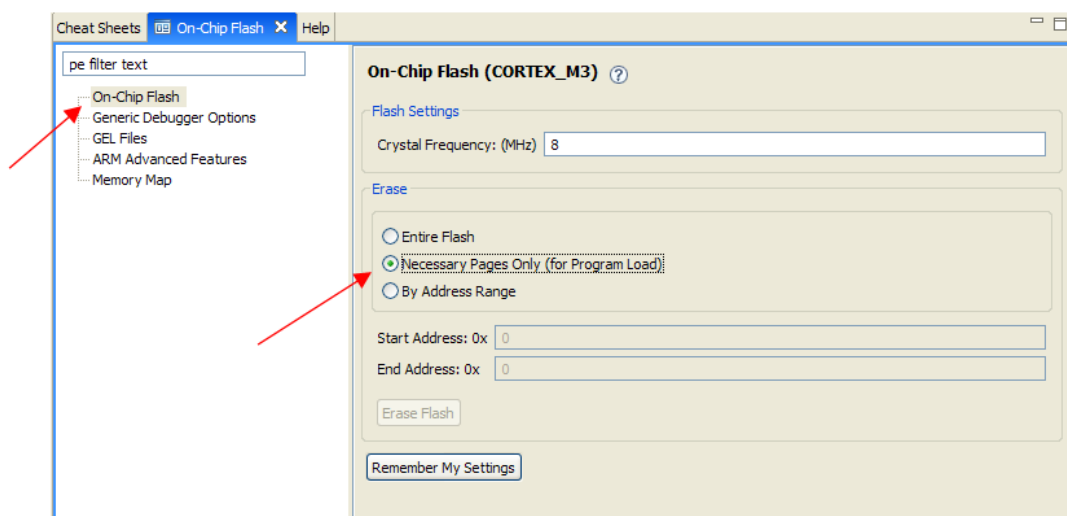
**Figure A-7. Changing the Flash Erase Option**

CCS does not work by default - it hangs when the debugger loads because the default flash erase option is mass erase (which won't work because the patch code is write protected). The flash erase option must be changed to page erase. To do this, start a debug session (even though it won't work correctly) to get access to the Flash settings. Once in the debug session, go to Tools  $\square$  On-Chip Flash then under Erase select "Necessary Pages Only (for Program Load)" as shown in Figure A-7 on page 23.

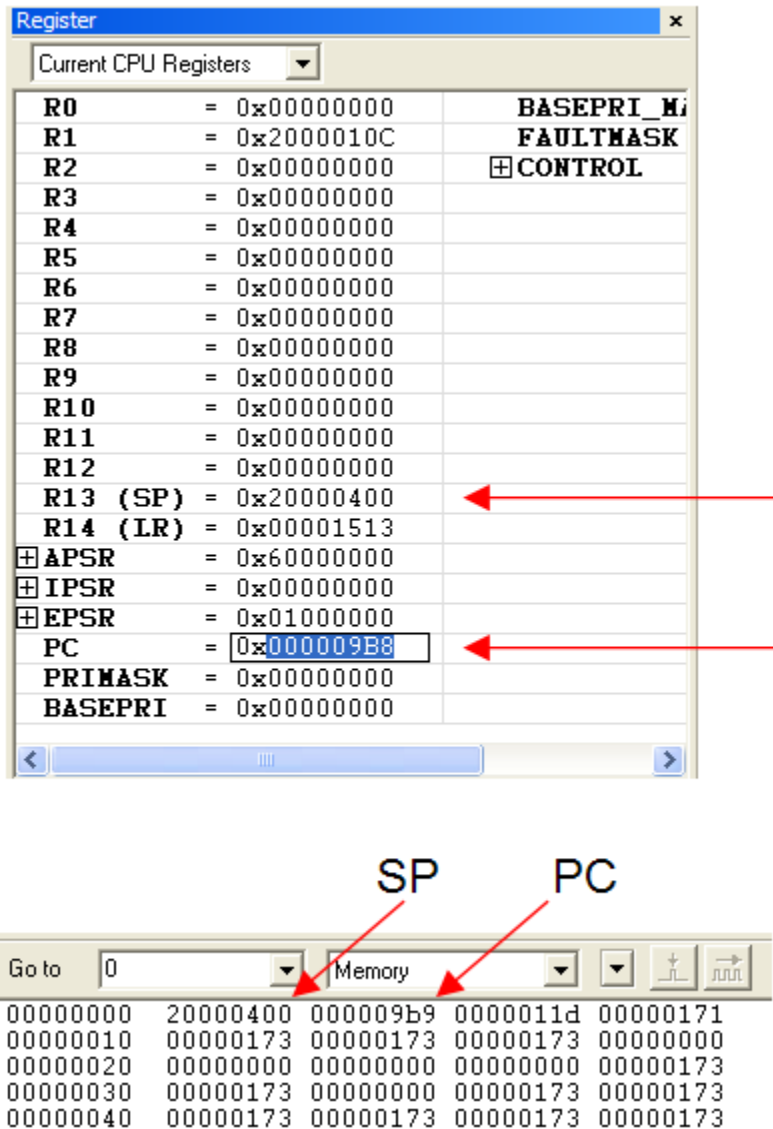
Figure A-9. Manually Configuring the PC and SP Registers

IAR has problems executing code at address 0x0000.0000 if it is not the main() application (such as bootloader examples). As a result, the PC and SP must be manually loaded. The values to load can be found at address 0x0000.0000 and 0x0000.0004 in the memory window and loaded into the PC (0x000009B8) and SP (0x20000400) as shown in Figure A-9 on page 25.

Set a breakpoint at the main() function and run the program. This process causes the Flash memory interrupt to be enabled and the debugger to operate as expected. Note: Every time you startup the debugger or do a reset in the IDE, you need to perform this sequence.
